Rapid Assessment of Remedial Effectiveness and Rebound in Fractured Bedrock

ESTCP Project ER-201330

OCTOBER 2017

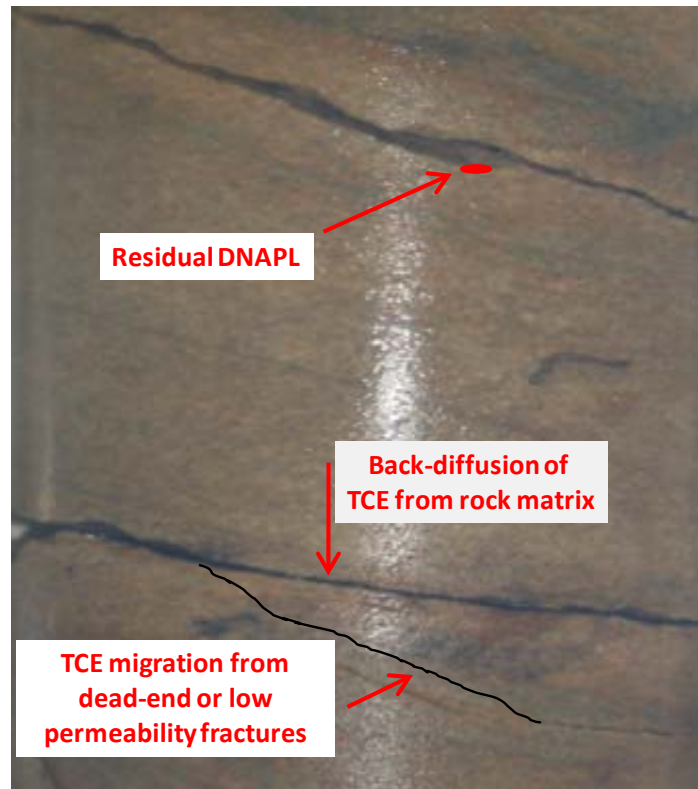
Figure 2.1. Illustration Showing Possible TCE Rebound Mechanisms in Fractured Bedrock.

There are many mechanisms that can contribute to contaminant rebound and sustained groundwater impacts in fractured bedrock aquifers. As illustrated in Figure 2.1 on the following page, these mechanisms include matrix back diffusion (Lipson et al., 2005; Sterling et al., 2005; West and Kueper, 2010), slow migration of contaminants from small or microfractures (USEPA, 2006), and/or the presence of DNAPL (Schaefer et al., 2012). For many sites, it is difficult to determine which of these mechanisms is responsible for the observed rebound (if rebound occurs), as the complexities associated with the flow field, aperture distribution, and contaminant distribution within the bedrock aquifer are difficult to quantify. Furthermore, many pilot tests are impacted from upgradient sources that migrate into the treatment area prior to evaluating rebound mechanisms, thereby preventing proper assessment of rebound during the post-injection period of the pilot test. The ability to isolate the treatment area to eliminate upgradient impacts would improve the ability to assess remedial effectiveness during pilot tests. However, approaches for comprehensively and cost effectively characterizing fractured bedrock aquifers to quantify these impacts have hitherto not been demonstrated.

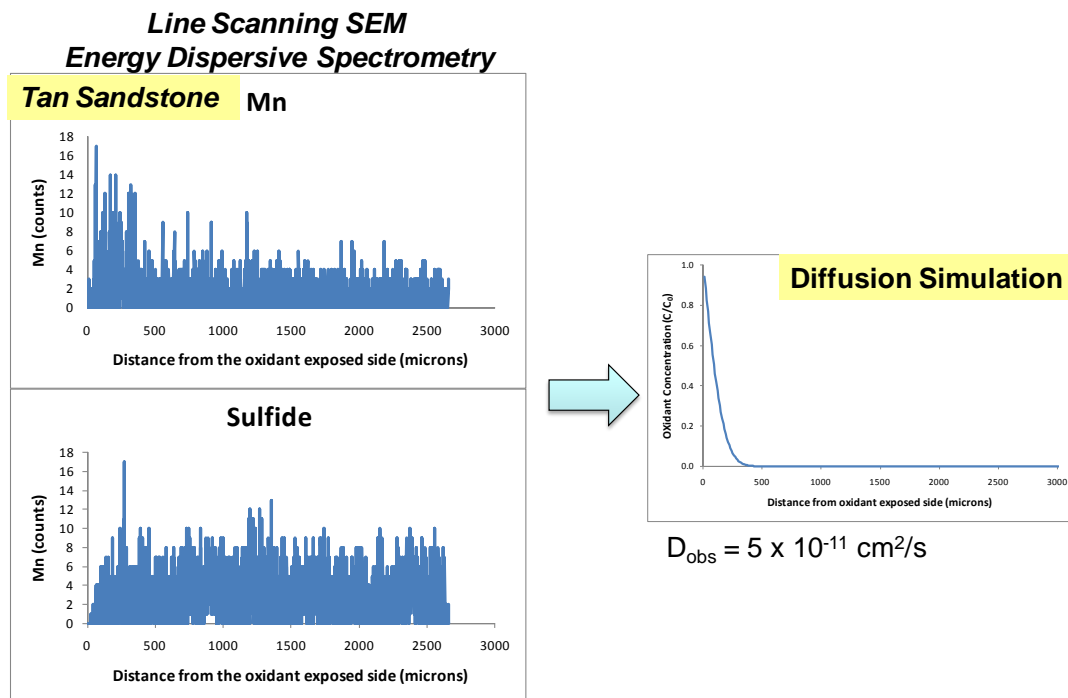
Figure 2.2. Diffusion of Permanganate into the Rock Matrix of a Tan Sandstone Collected from the Former Naval Air Warfare Center in Trenton, NJ (Huang et al., 2014).

Permanganate was in contact with the rock for 20 days. Line scanning SEM, which was able to show the diffusion profile via Mn deposition and sulfide depletion, showed that the oxidant migrated less than 400 microns into the rock. The observed diffusion coefficient was $5 \times 10^{-11} \text{ cm}^2/\text{s}$.

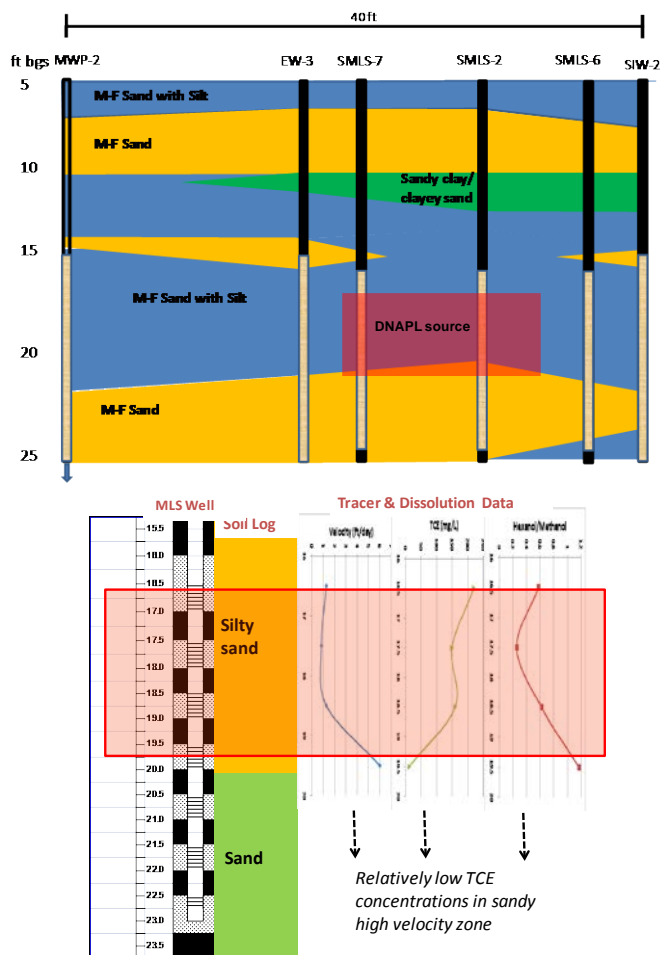
Conceptual cross section showing the TCE DNAPL source area at Alameda. Clean groundwater was recirculated through the system to enhance DNAPL dissolution using the injection and extraction wells that bounded the DNAPL source. Groundwater was passed through carbon to ensure that TCE-free groundwater was re-injected.

Using data from a single MLS well, along with results from conservative and partitioning tracer tests, a conceptual model for the system could be developed. DNAPL sources were located in the low flow zone, as indicated by tracer partitioning (low ratio of hexanol to methanol). Use of the MLS wells allowed the impacts of DNAPL dissolution on groundwater quality to be quantified, as VOC rebound was observed following recirculation.

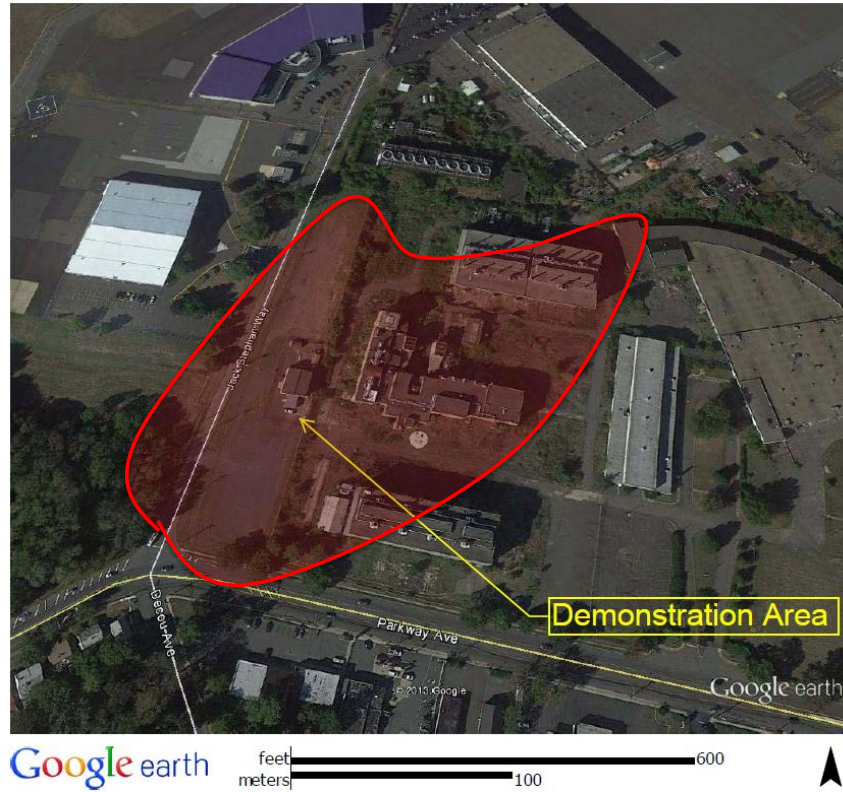
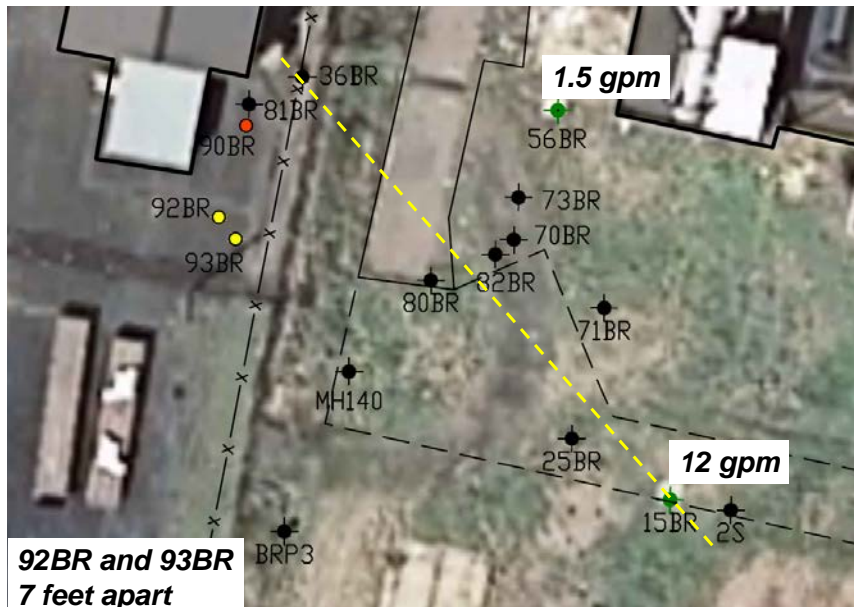
Figure 4.1. Demonstration Location at the NAWC Site.

The shaded area represents the bedrock TCE plume, where TCE is present at detectable concentrations (top). Demonstration wells (92BR and 93BR) and other local bedrock wells also are shown (bottom).

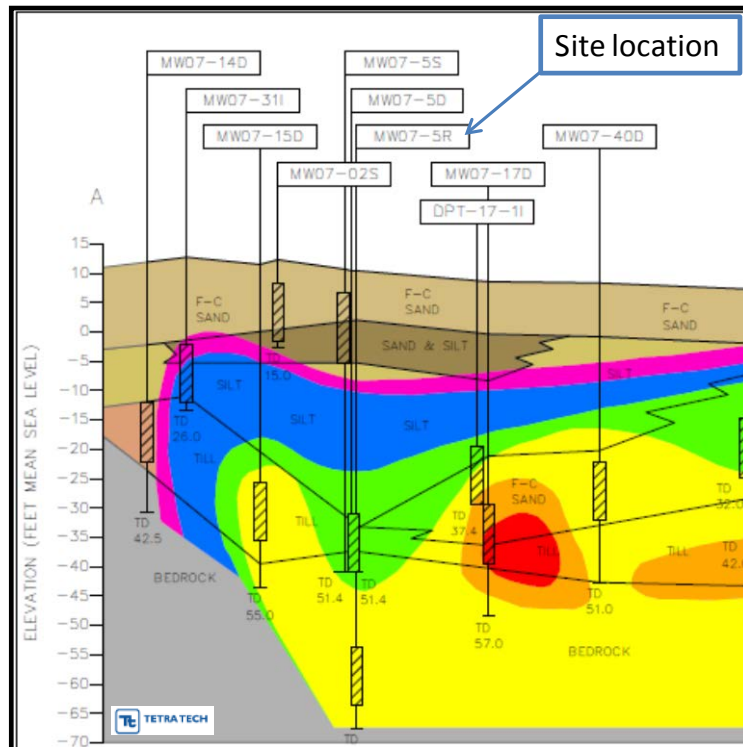
Figure 4.4. Cross-sectional View of the Demonstration Location at Calf Pasture Point.

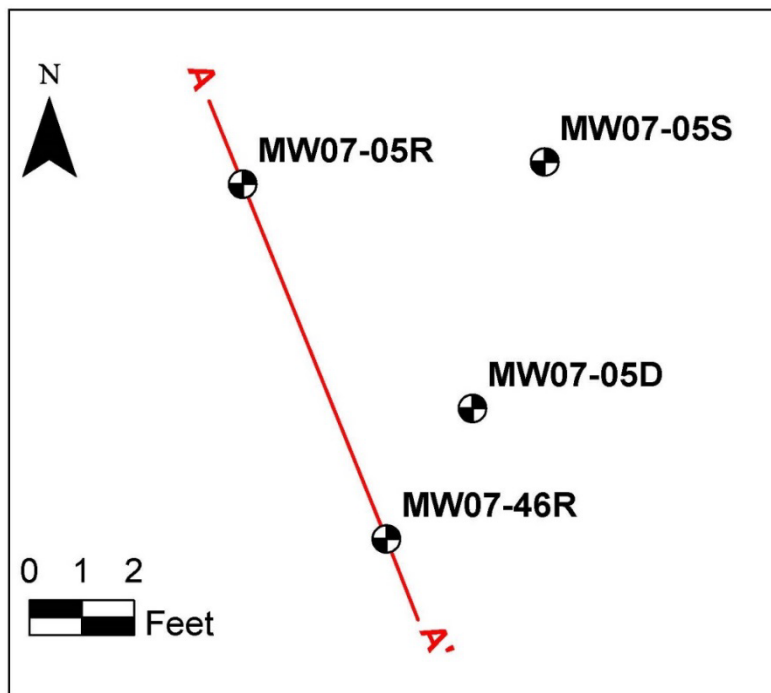
Figure 5.1. CPP Demonstration Area (circled), with Location of Newly Installed Borehole (MW07-46R) Identified (approximately 8 feet from existing well MW07-05R).

Characterization activities included drilling and coring one borehole located approximately 8 feet downgradient from existing bedrock well MW07-05R. This bedrock well was installed in August, 2014. The newly installed open borehole well was designated MW07-46R, and its location is shown in Figures 5.1 and 5.2. Details of the well installation, rock core collection, and borehole testing are provided in the following sections.

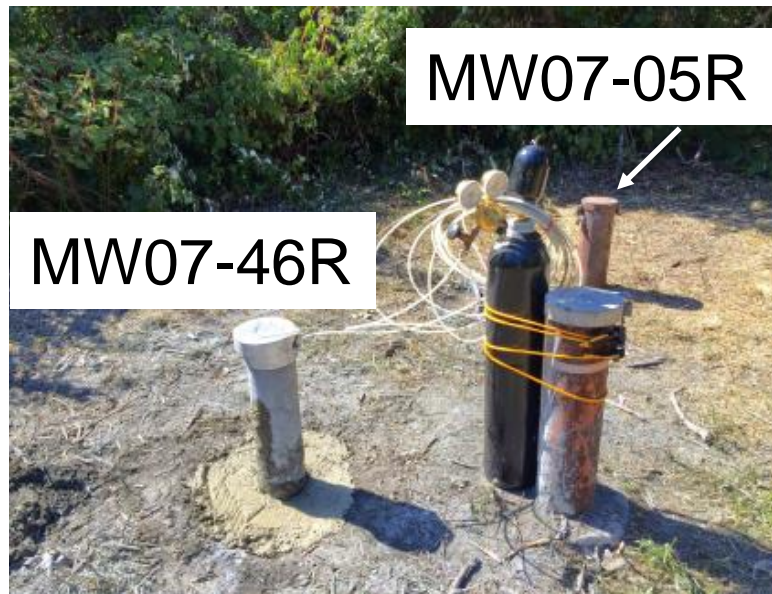
Figure 5.2. Newly Installed Well MW07-46R Shown in Proximity to Existing Well MW07-05R.

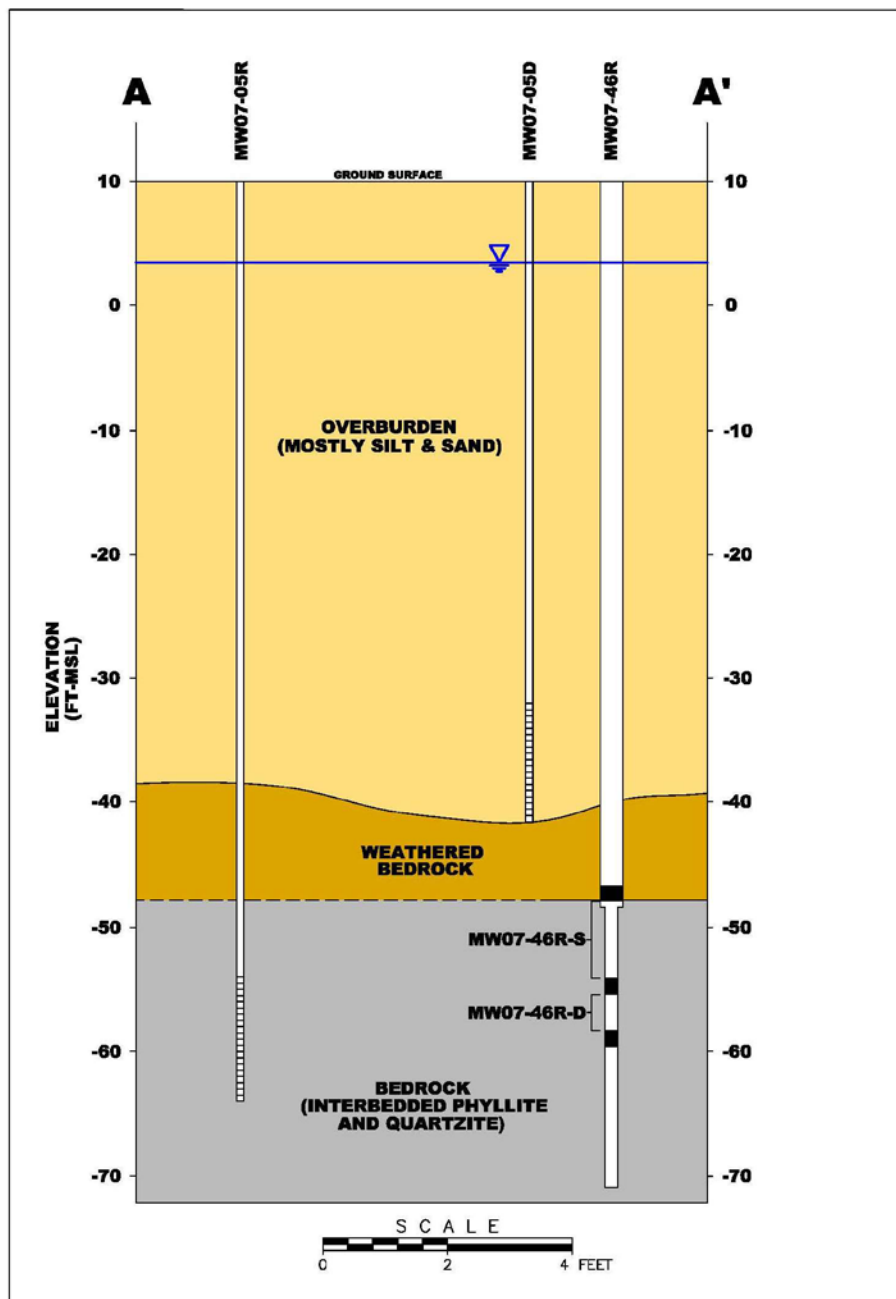
Figure 5.3. Generalized Geologic Cross Section of the CPP Demonstration Area.

The boring log for MW07-46R is provided in Appendix C, and indicates that the competent bedrock between 58.3 and 80.6 ft bgs consisted of interbedded quartzite and phyllite. A generalized geologic cross section of the demonstration area is provided in Figure 5.3. Visual logging of the rock core indicated that several water bearing fractures were located between 58.3 and 63 ft bgs. Very few fractures were noted between 63 and 80.6 ft bgs; the absence of mineral staining on the fractures in this deeper interval suggested that the fractures may not be water-bearing.

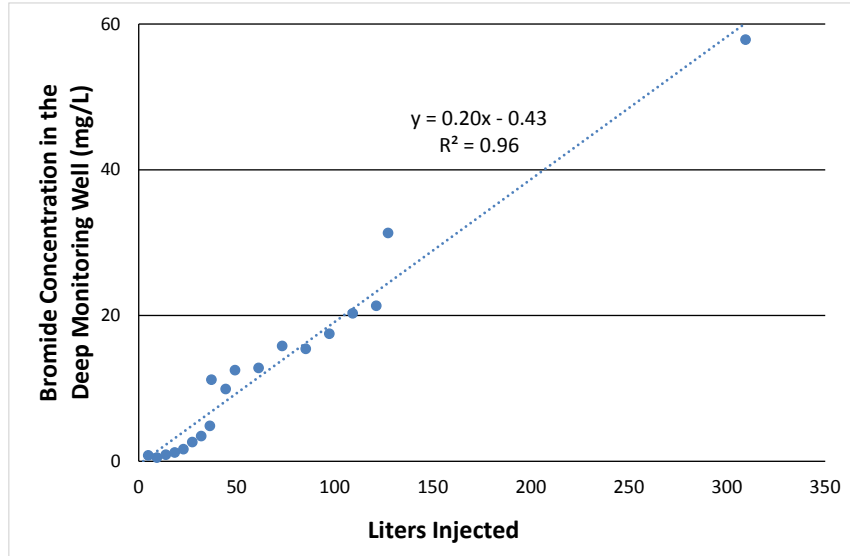
Figure 5.4. Increases in Bromide Concentration in the Deep Interval of MW07-46R as a Function of Volume Injected into MW07-05R.

The dashed line shows the linear regression to the data.

Bromide data for the shallow and deep intervals for MW07-46R are provided in Figure 5.4. No measurable bromide was observed in the shallow, indicating that no significant flow path (despite observing a hydraulic connection during the short term pumping tests) exists between the injection well (MW07-05R) and the shallow interval of MW07-46R.

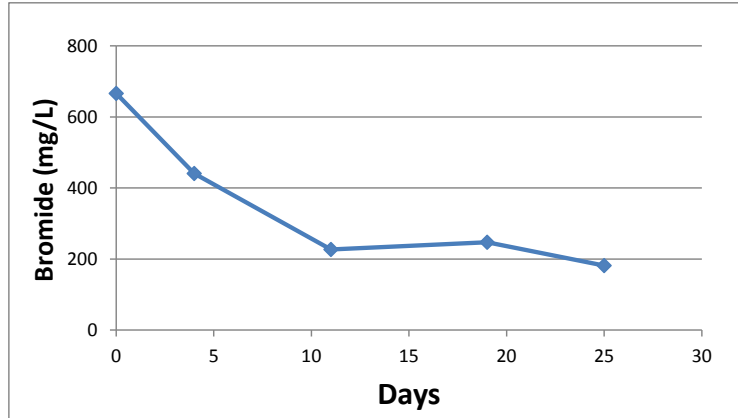
Figure 5.5. Results from the Borehole Dilution Testing Performed in the Injection Well (MW07-05R).

A 250 mL solution containing 8.9 grams of NaBr was added to the 11-foot interval below the packer to achieve a target bromide tracer concentration in the water column of 500 mg/L. Immediately following the addition of the sodium bromide tracer, water was recirculated within the well using the dedicated bladder pump installed below the packer to facilitate tracer mixing throughout the 11-ft interval. This was accomplished by pumping groundwater from near the top of the interval up to the ground surface. The water was continuously re-injected back through the packer to the top of the packer interval. Approximately 5.5 gallons (3 isolated interval volumes) was recirculated to sufficiently mix the bromide tracer within the interval. Bromide samples were collected from MW07-05R after recirculation (time=0), and on days 4, 11, 19 and 25. As with the tracer testing detailed in Section 5.2.6, samples were collected by recirculating ~600 mL (1.2 pump and tubing volumes) of water from the dedicated sample pump, to the surface, and back into the sampling interval to minimize the removal of groundwater from the expected small fracture volume between the injection and monitoring well. Approximately 10 mL of sample were collected for laboratory analysis at the end of each 600 mL recirculation. These data are presented in Figure 5.5.

The rate of decay of bromide from the injection well provides an estimate of the Darcy velocity. The Darcy velocity is calculated as follows (Pitrak et al., 2007; Nordqvist et al., 2008):

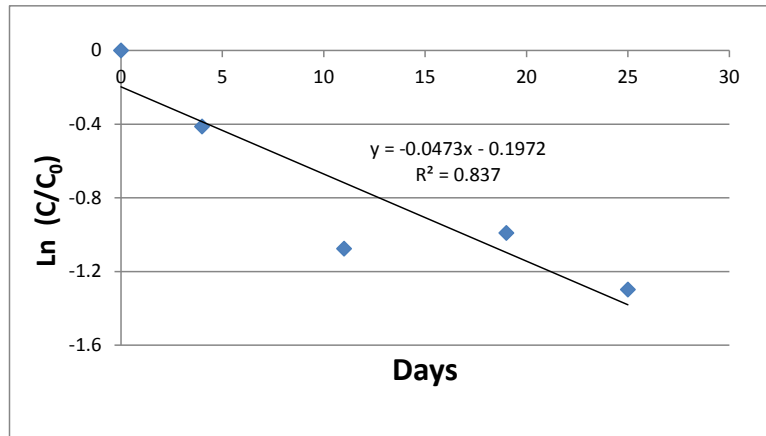
Figure 5.6. Linear Regression of the Bromide Data from the Borehole Dilution Test Performed at MW07-05R.

The bromide data are plotted in the form of Eq. 4 to facilitate determination of the ambient water flow rate into the borehole via linear regression. The linear regression to the data is represented by the solid line.

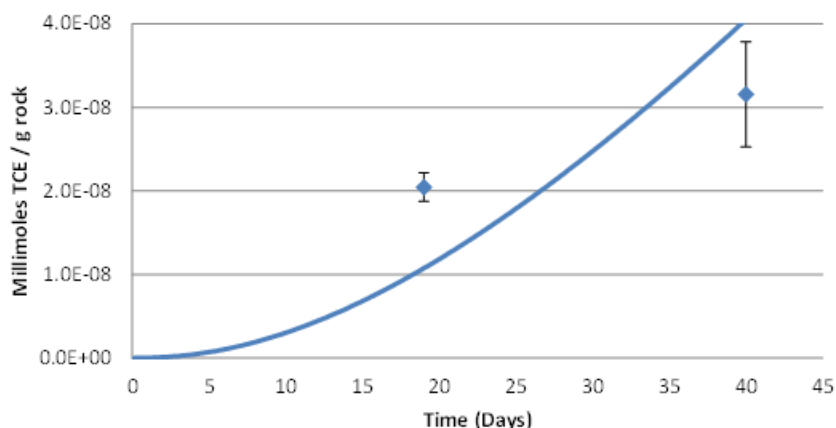
Figure 5.7. Abiotic Dechlorination of TCE in the Bench Scale Batch Testing.

Total TCE transformation was based on the generation of ethane and propane. Error bars represent 95% confidence intervals. Only data from two of the three replicates was used, as one of the replicates exhibited clear indications of leakage. The solid line represents the model regression (Schaefer et al., 2013, 2015) to the data. Error bars represent 95% confidence intervals of the triplicate data.

Results of the abiotic batch dechlorination testing showed that abiotic dechlorination transformation products ethane and propane were generated in the TCE-spiked vials, consistent with previous abiotic testing in bedrock (Schaefer et al., 2013, 2015). Results plotted at total millimoles of TCE per g rock transformed are provided in Figure 5.7. Using a trial-and-error approach to estimate (within a factor of 2) the first-order TCE transformation rate constant via application of a coupled diffusion and first-order TCE transformation model (Schaefer et al., 2013) yield a rate constant of $2.7 \times 10^{-8} \text{ s}^{-1}$.

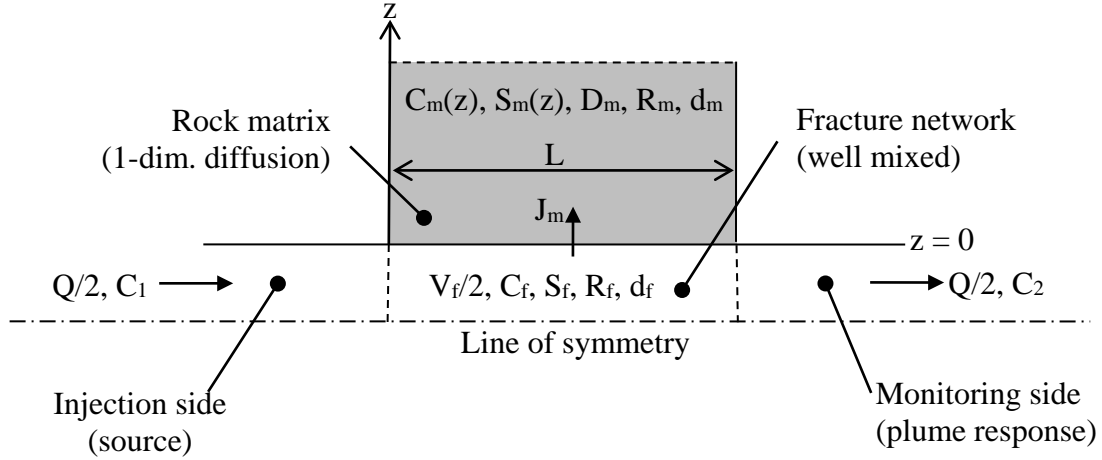
Figure 5.8. Conceptual Model of Transport by Fracture Flow Coupled with Matrix Diffusion (showing upper half of symmetric problem).

As illustrated in Figure 5.8, the model considers a well mixed fracture network of volume V_f [L^3] conveying a volumetric groundwater flow Q [L^3/T] entering from the left (injection well side) with aqueous contaminant source concentration C_1 [M/L^3] and leaving on the right (monitoring well side) with contaminant plume concentration C_2 [M/L^3]. In the rock matrix extending, there is no flow, but there is diffusive one-dimensional transport with diffusion coefficient D_m [L^2/T]. At the fracture-matrix interface of length L and located at $z = 0$ a diffusive mass flux J_m [M/T] occurs, which is taken positive for transport into the matrix. The dissolved contaminant concentrations in the fracture and the matrix are denoted by C_f [M/L^3] and C_m [M/L^3], respectively. The corresponding linearly and instantaneously sorbed contaminant masses per unit fracture or matrix pore volume are denoted by S_f and S_m [M/L^3]. Note that $C_f(t)$ and $S_f(t)$ are functions of time t [T] only, whereas $C_m(z,t)$ and $S_m(z,t)$ are functions of both z and t . Finally, retardation factors (defined as the total contaminant mass in the dissolved and sorbed phases, divided by the dissolved contaminant mass) are denoted by R_f [-] and R_m [-], respectively. First order degradation rates of contaminants in fracture and matrix are denoted by d_f [$1/T$] and d_m [$1/T$]. Note that d_f is applied to the dissolved phase, while d_m is applied to the sorbed phase (in contact with reactive rock material). For dimensional consistency, a transverse width (perpendicular to the plane shown in Figure 5.8) of the model was adopted as W [L]. As discussed in Section 5.2, 3 fractures are present connecting the injection well to the monitoring well, so the overall contaminant and water flux into the monitoring side well are multiplied by 3 in the model. It is noted that, due to the low value of D_m coupled with the value of d_m , model results shown that contaminant (TCE) migration into the rock matrix is very limited (< 3 cm), and thus assuming an infinite medium in the z direction for the rock matrix was shown to be a reasonable assumption.

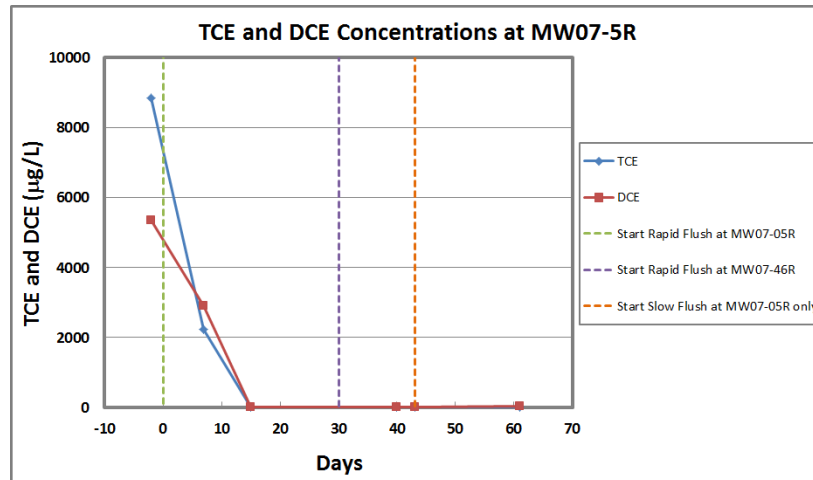
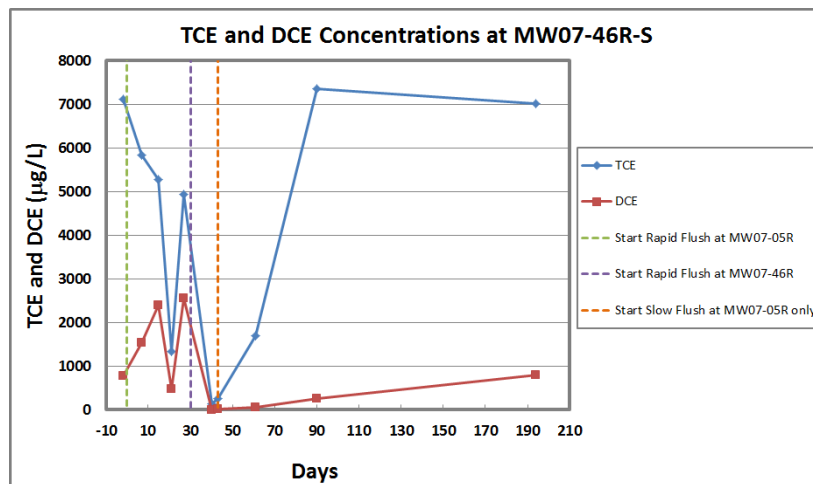
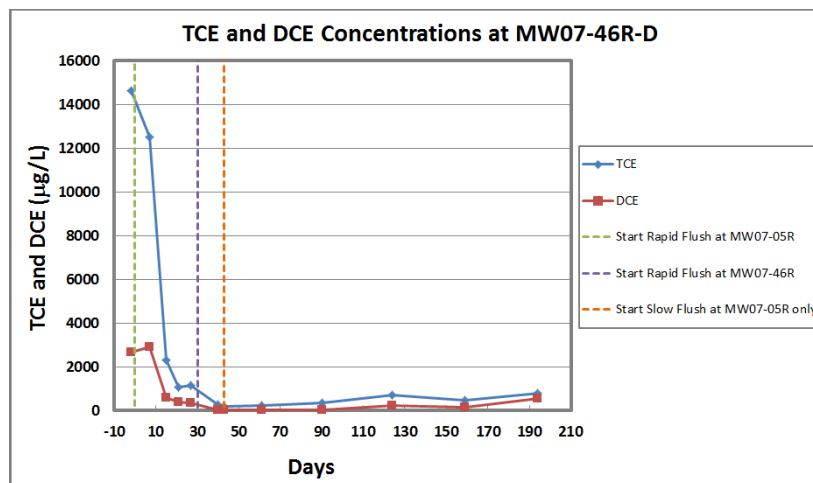
Figure 5.10. TCE and DCE Concentrations Measured Throughout the RA Demonstration.

Results of the rapid flushing are summarized in Figure 5.10 below. Rapid flushing was initiated on April 5, 2016 and terminated on May 19, 2016. The rapid flushing was effective in removing >90% of the cVOCs in both the shallow and deep monitoring locations (approximately 98.6% of the TCE was removed in the deep monitoring interval). However, the shallow monitoring location only showed substantial cVOC removal after water was injected directly into the monitoring interval. This result was not unexpected, as the tracer testing showed that the injection well and shallow monitoring interval were poorly connected. As described in Section 5.8.3, evaluation of rebound was therefore limited to the deep interval.

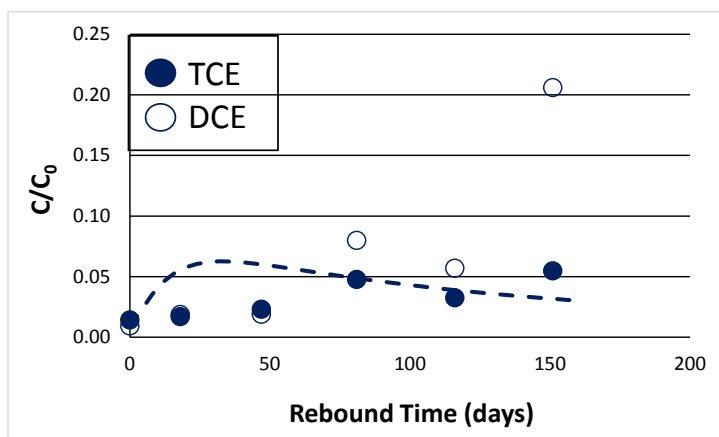
Figure 5.11. Increases of TCE and DCE Relative to their Baseline (prior to rapid flushing) Levels during Rebound at MW07-46R-D.

The dashed line represents the TCE model prediction (Section 5.6.1).

Increases in TCE and DCE relative to baseline (Table 5.6) plotted as a function of time are shown in Figure 5.11. Results show that TCE and DCE concentrations increased with time, indicating that there was a persistent contaminant mass present between the demonstration wells that was not removed during the rapid flushing.

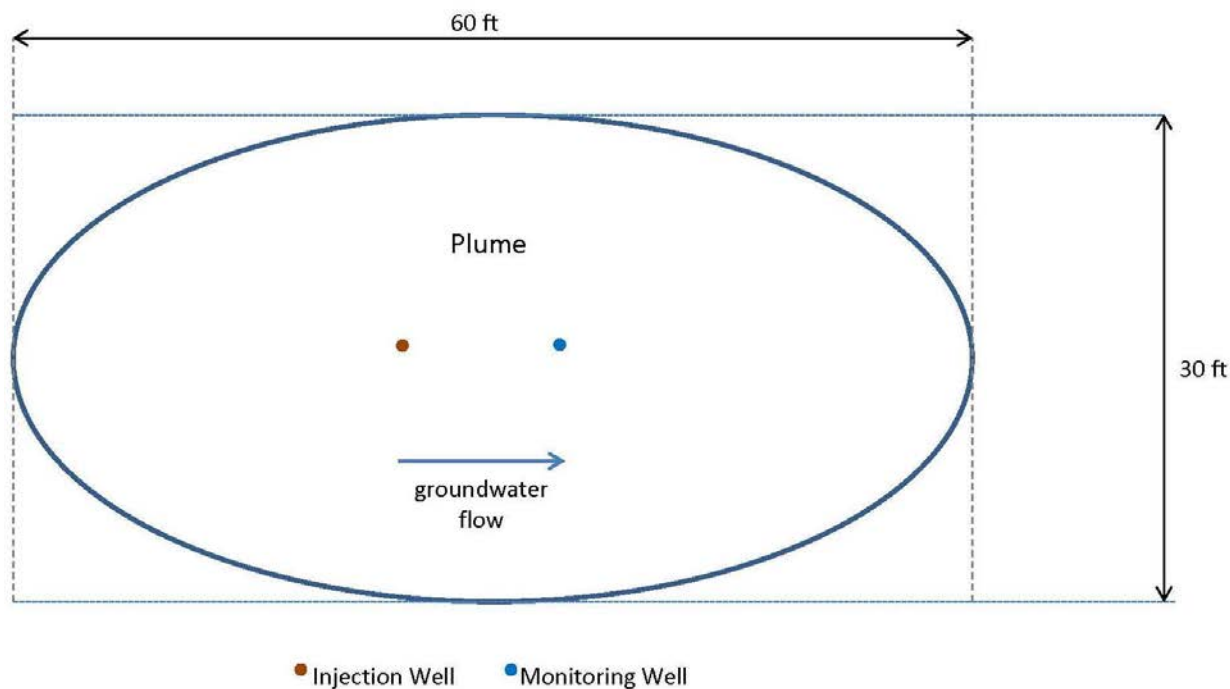
Figure 7.2. Rapid Assessment Technology Approach

This alternative ranks lower in estimated total remedy cost (see Table 7.4) when compared to the bioremediation recirculation pilot test (see Section 7.3.3). This is mainly due to the lower capital costs associated with the well drilling and system components, as well as the lower O&M and groundwater monitoring costs.

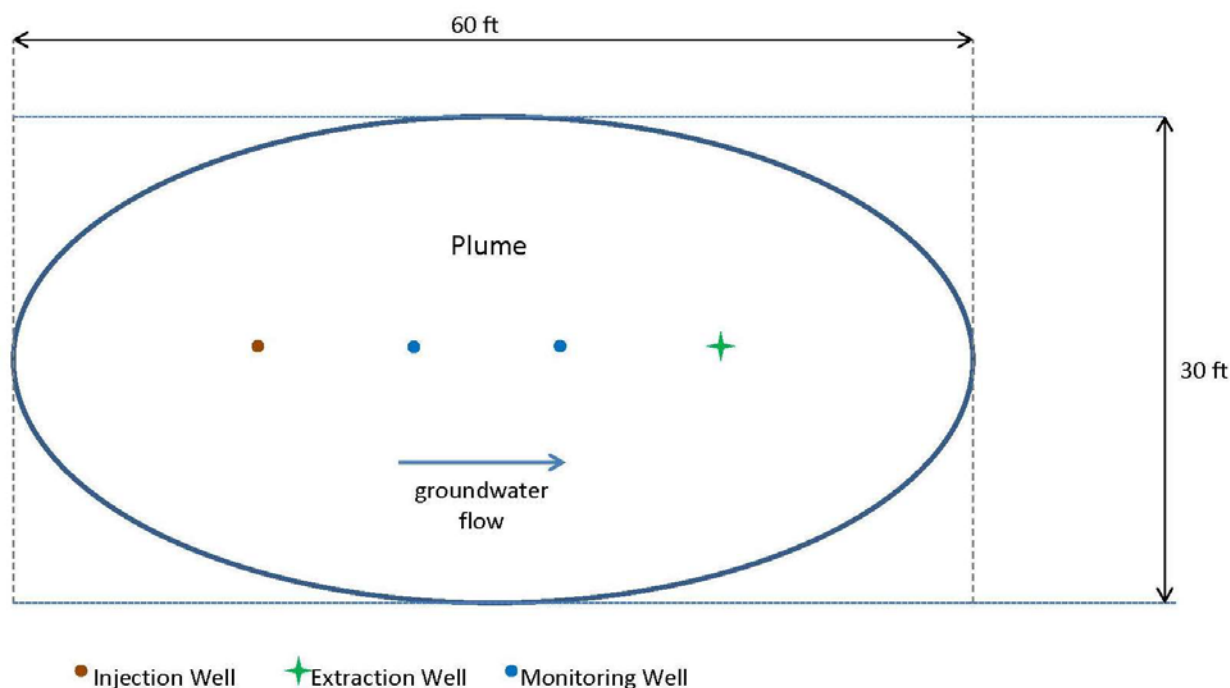
Figure 7.3. Bioremediation Recirculation Pilot Study

This alternative has an estimated total remedy cost almost double that of the Rapid Assessment approach, mainly due to the higher capital costs associated with the well drilling and higher O&M and groundwater monitoring costs during the 1 year active treatment period (see Table 7.4). *It also is critical to note that the bioremediation recirculation study likely will not provide the mechanistic information that the RA approach provides.*

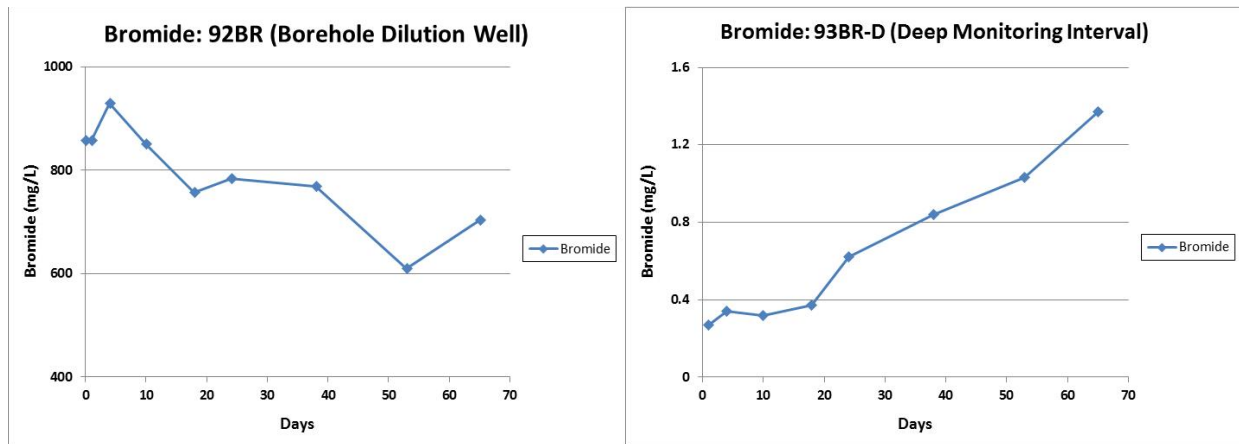
Figure 2: Bromide Concentrations in the Injection Well (Panel A) and MLS Well Deep Interval Well (Panel B) during the Passive Phase of Borehole Dilution/Tracer Testing.

In order to verify connectivity between the wells and to better estimate the effective fracture porosity, pumping was performed within the shallow and deep intervals of the monitoring well using the dedicated sampling pumps installed in those intervals. The deep monitoring well interval was pumped at approximately 75 mL/min for approximately 11 hours, and the shallow monitoring well interval was pumped at increasing steps between 75 mL/min and 450 mL/min for approximately 35 hours. Pumping was performed during the day, and discontinued at the end of each work day. Bromide samples were collected every 20 to 60 minutes to determine the time of breakthrough, and to develop a bromide curve for estimating effective fracture porosity. During this groundwater extraction phase, bromide concentrations in the injection well showed a steady decrease from 704 mg/L to 273 mg/L (**Figure 3**). The deep monitoring interval showed a steady increase and flattening of bromide concentrations at approximately 15 mg/L, while the shallow monitoring well interval showed a relatively steady increase and flattening of bromide concentrations at approximately 0.7 mg/L (**Figure 3**). Results from the deep interval confirmed that the flow path from the injection well to the MLS well was sufficient for the demonstration. The very low bromide levels measured in the shallow zone suggested that the majority of the flow into this shallow zone was not emanating along the flow path connected to the bromide tracer.

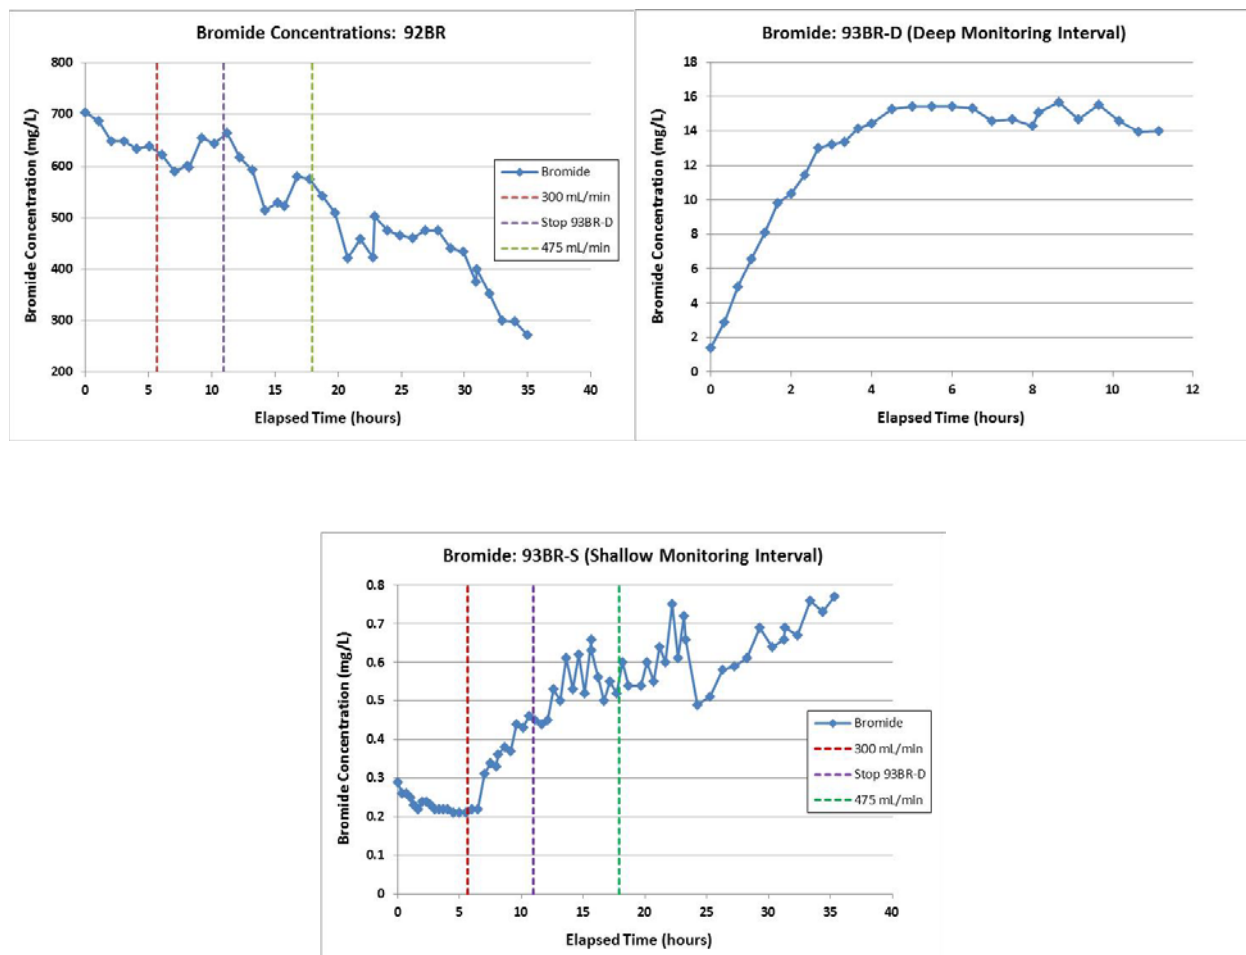
Figure 3: Bromide Concentrations in the Injection Well (Panel A), MLS Well Deep Interval Well (Panel B), and MLS Well Shallow Interval Well (Panel C) during the Pumping Phase of Borehole Dilution/Tracer Testing.

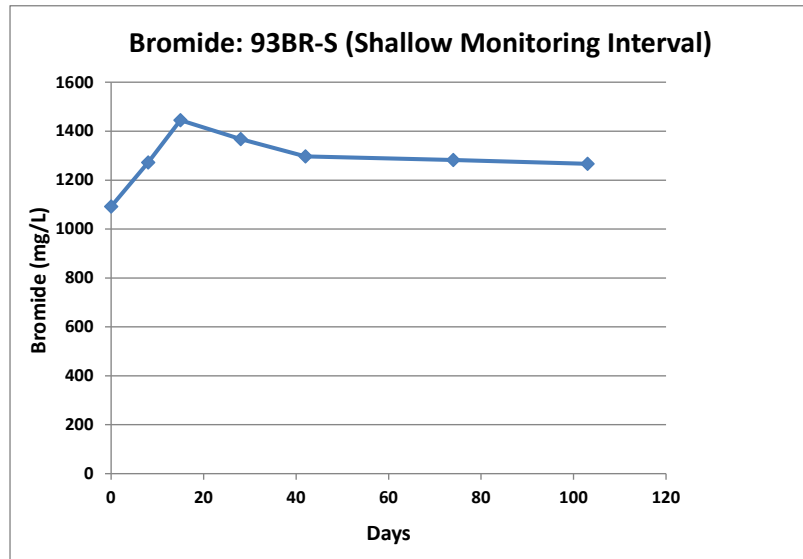
Figure 3: Bromide Concentrations in the MLS Well Shallow Interval during Borehole Dilution Testing Performed at the End of the RA Test.

A second borehole dilution tracer test was initiated at the NAWC on September 24th, 2015. The purpose of this second borehole dilution test was to verify what the Darcy flow into the monitoring well was during the rebound testing. As shown in Figure 4, bromide flushing from the well under ambient conditions was negligible. This lack of flow was assumed to be due to a loss in permeability resulting from precipitation of manganese oxides.

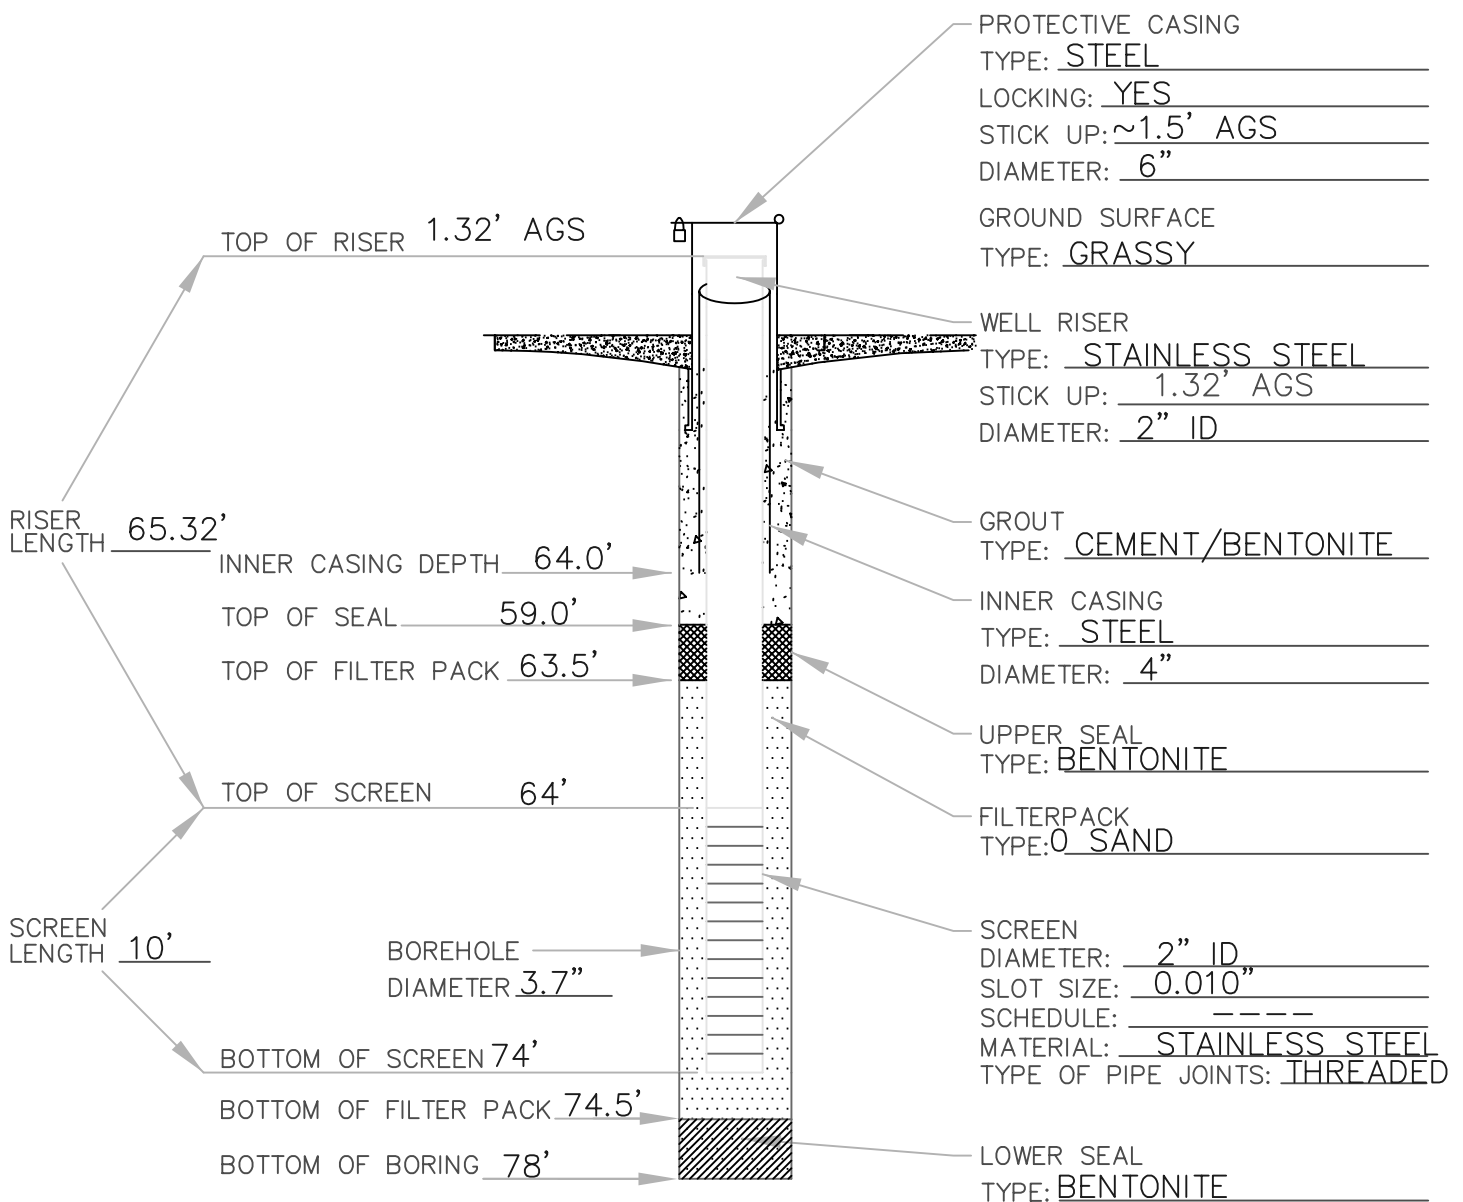
MW07-05R

CLIENT/SITE NAME: NORDIV, NAVFAC NCBC DAVISVILLE, SITE 07, PHASE III RI	
DATE INSTALLED: 8/24/95	PROJECT No. 29600.32
ELEVATION OF GROUND SURFACE: 10.3' MSL ELEVATION TOP OF WELL RISER: 11.62' MSL	COORDINATES: N: 197588.42 E: 524597.83
DEPTH TO WATER: 7.88' (BELOW TOP OF RISER) DATE/TIME 12/1/96 1220	EA INSPECTOR: J. SHAPIRO
DRILLING METHOD & DEPTH: 6" FLUSH-JOINT CASING WITH 5.875" ROLLERBIT TO 64'/ HX-CORE 64'-77.5'

MONITORING WELL CONSTRUCTION
(ALL DEPTH MEASUREMENTS IN FT. BELOW GROUND SURFACE)

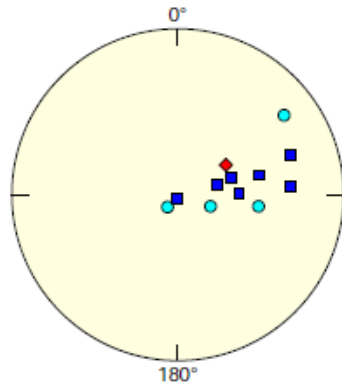
Schmidt Plot - LH - Bedrock Structures

Counts	Dip[deg]	Azi[deg]
Mean	12	33.66	269.18
◆	1	28.23	237.95
■	7	34.57	267.42
●	4	33.49	287.51

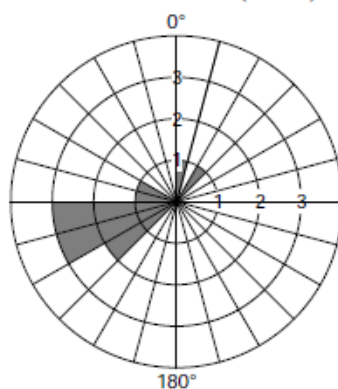
Azimuth - Absolute (Count)

Counts:	12.00
Mean:	269.18
Std.Dev.:	47.30
Min:	13.88
Max:	290.10

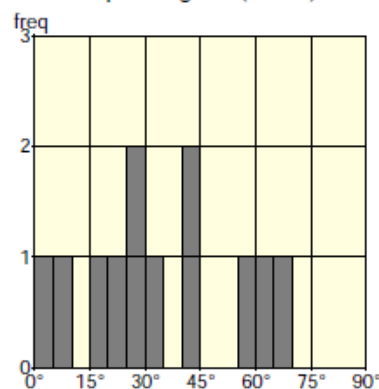
Dip Histogram (Count)

Counts:	12.00
Mean:	33.66
Std.Dev.:	20.37
Min:	1.87
Max:	69.04

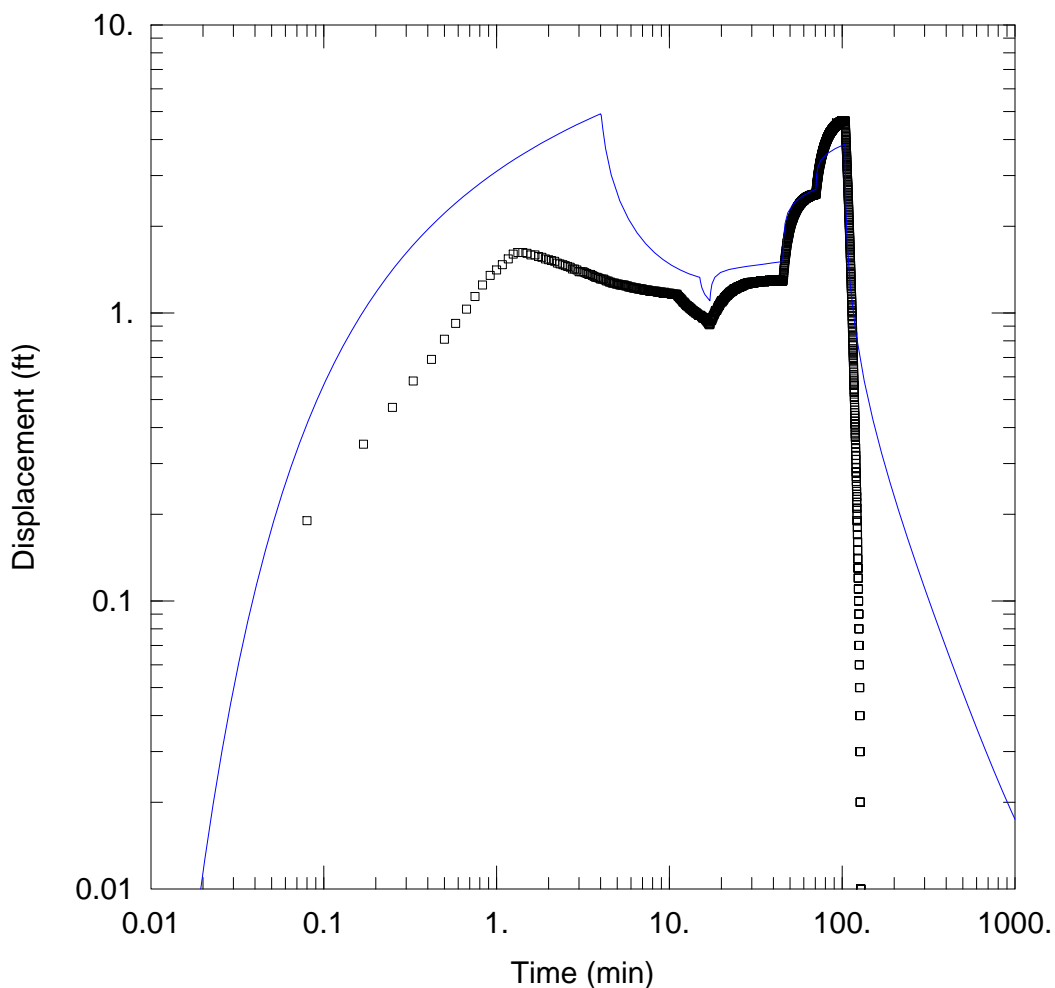
TEST #1: RESPONSE AT MW07-46R 58.3'-64.7' BGS TO PUMPING AT MW07-46R 58.3'-64.7'

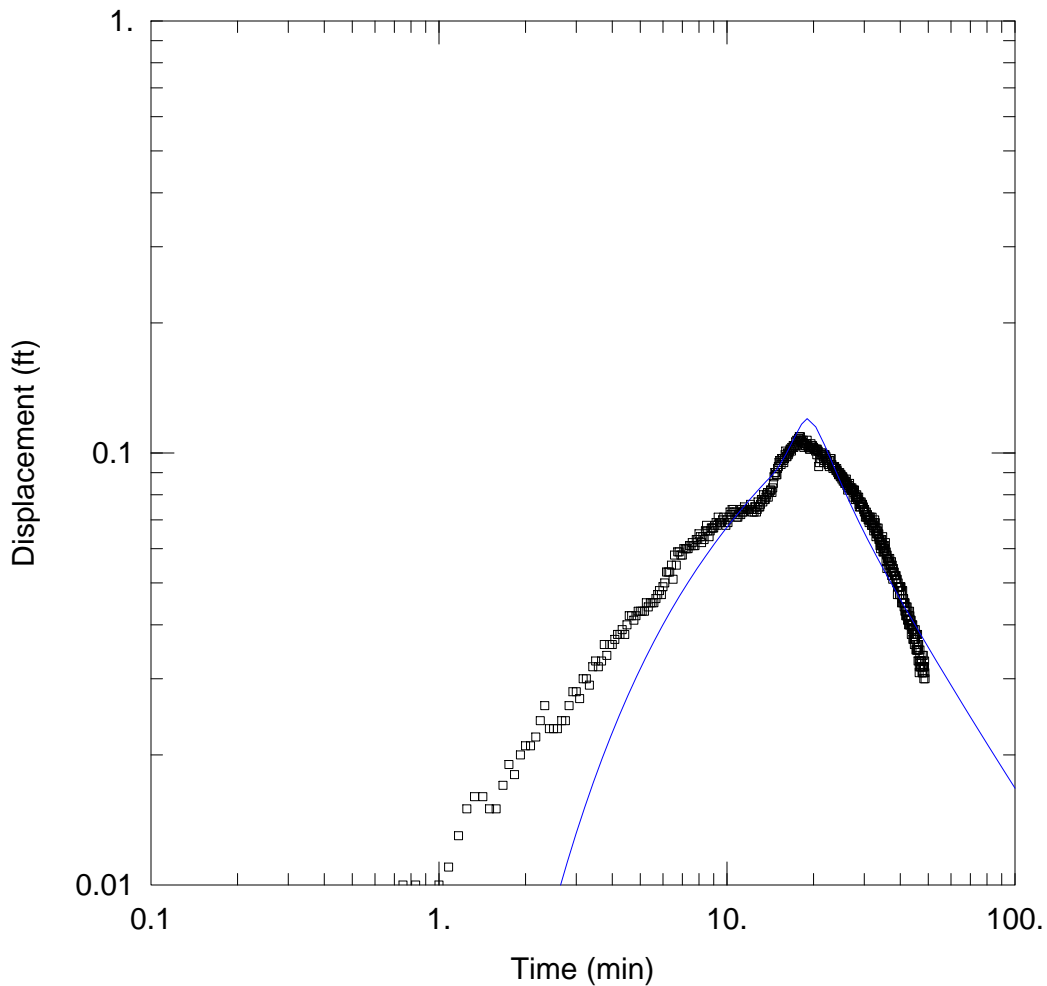
TEST5: RESPONSE AT MW07-46R 65'-69" BGS TO PUMPING AT MW07-05R 64'-74' BGS

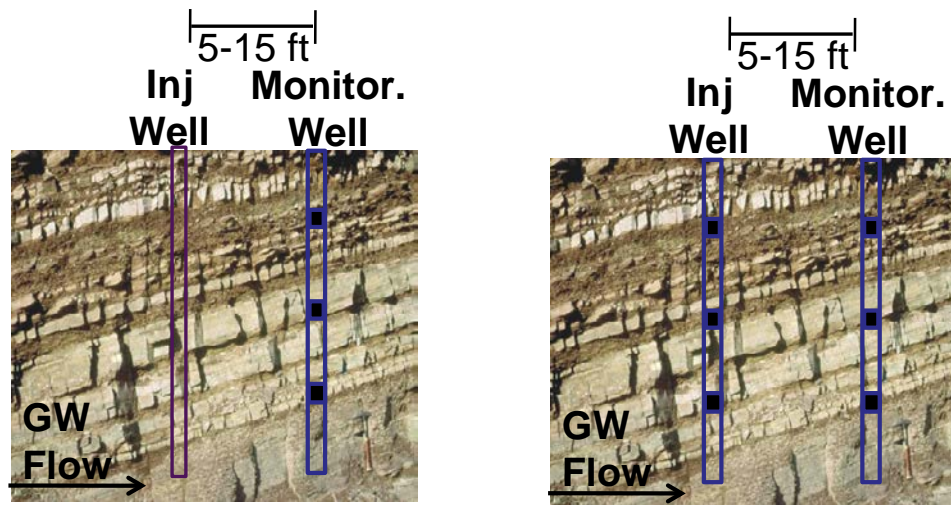
Figure 1. The injection well can be configured such that the open borehole injection interval spans the interval of the multi-level monitoring well (left), or the injection well can be configure as a multi-level injection well (right).

Using the isolated fracture intervals, hydraulic testing should be performed for each target interval. Short term pump or drawdown testing should be used to estimate the hydraulic conductivity within each interval, and to confirm a hydraulic connection between the injection and monitoring well intervals. A borehole dilution test is needed in the injection well across the entire injection interval. The injection interval of the injection well can be a single zone extending across the multiple discrete intervals of the monitoring well, or multiple injection intervals corresponding to fracture zones in the monitoring well (see Figure 1 below). This information is used to determine the ambient flow into the injection well, and ultimately the injection rate needed to provide the hydraulic control needed during the slow injection (rebound) phase of the RA testing (Section IV). Borehole sampling should be performed to limit the volume of water removed from the borehole via strategies such as in-well recirculation of fluids.
